## Scholes Lodge Farm, Scholes, West Yorkshire

### Archaeological Assessment of Development Proposals

Report reference: 84231.01

**September 2012**

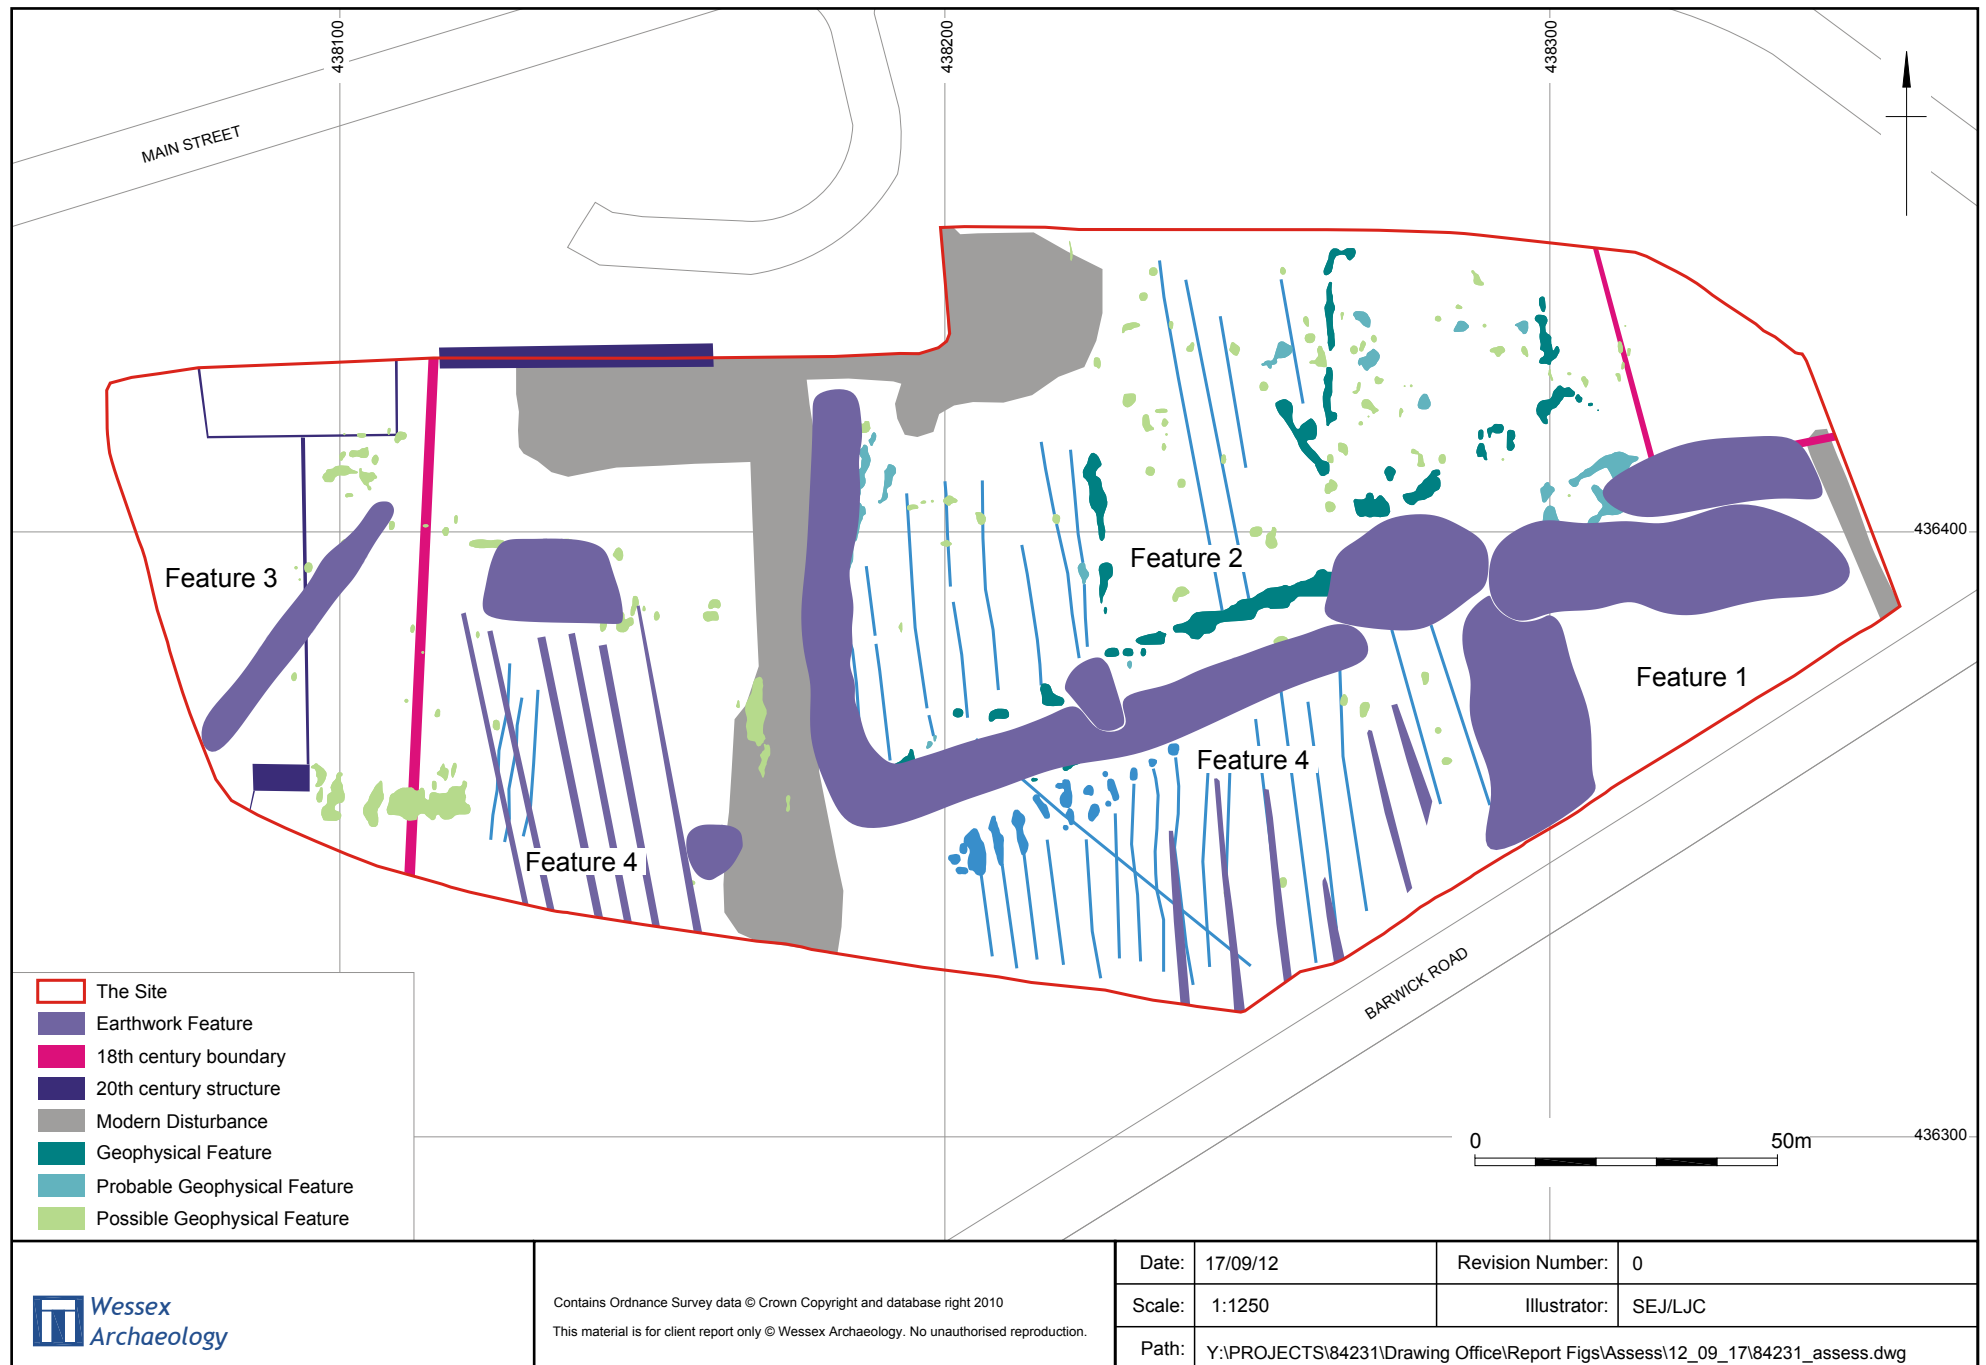
Figure 2

- 2.2.1 The archaeological and historical significance of the Site has long been apparent due to the presence of earthworks indicating the former location of a medieval moat and surrounding agricultural fields.
- 2.2.2 The earthwork and cropmark features within the Site were mapped between 2005-6, as part of the Magnesian Limestone in West and South Yorkshire Air Photo Mapping Project conducted by English Heritage. In 2006 Archaeological Services WYAS carried out excavations within the former Scholes Lodge Farm building complex (north of the Site) and in 2012 geophysical and topographic surveys of the Site were carried out by Wessex Archaeology.
- 2.2.3 These surveys combine to reveal the following information about the major upstanding feature groups within the Site (**Figure 2**):

Composite Plan of Archaeological and Historic Features

- Footpaths should as far as possible be routed through the areas of no, low and medium archaeological potential (see **Figure 3**).
- Where the paths cross into the area of high potential they should avoid known features (**Figure 2**) and/or utilise the edges of the Site where 20<sup>th</sup> century developments may already have caused some disturbance.

- Where possible, benches and information boards should be sited away from archaeological features identified by previous surveys (**Figure 2**).
- Where possible, benches and information boards should be sited at the edges of the Site where adjacent development may have already disturbed the ground.

- It is recommended that the moat in the southeast corner of the Site (Feature 1 on **Figure 2**) is selected for sowing as this would both define the moated enclosure and protect its interior.

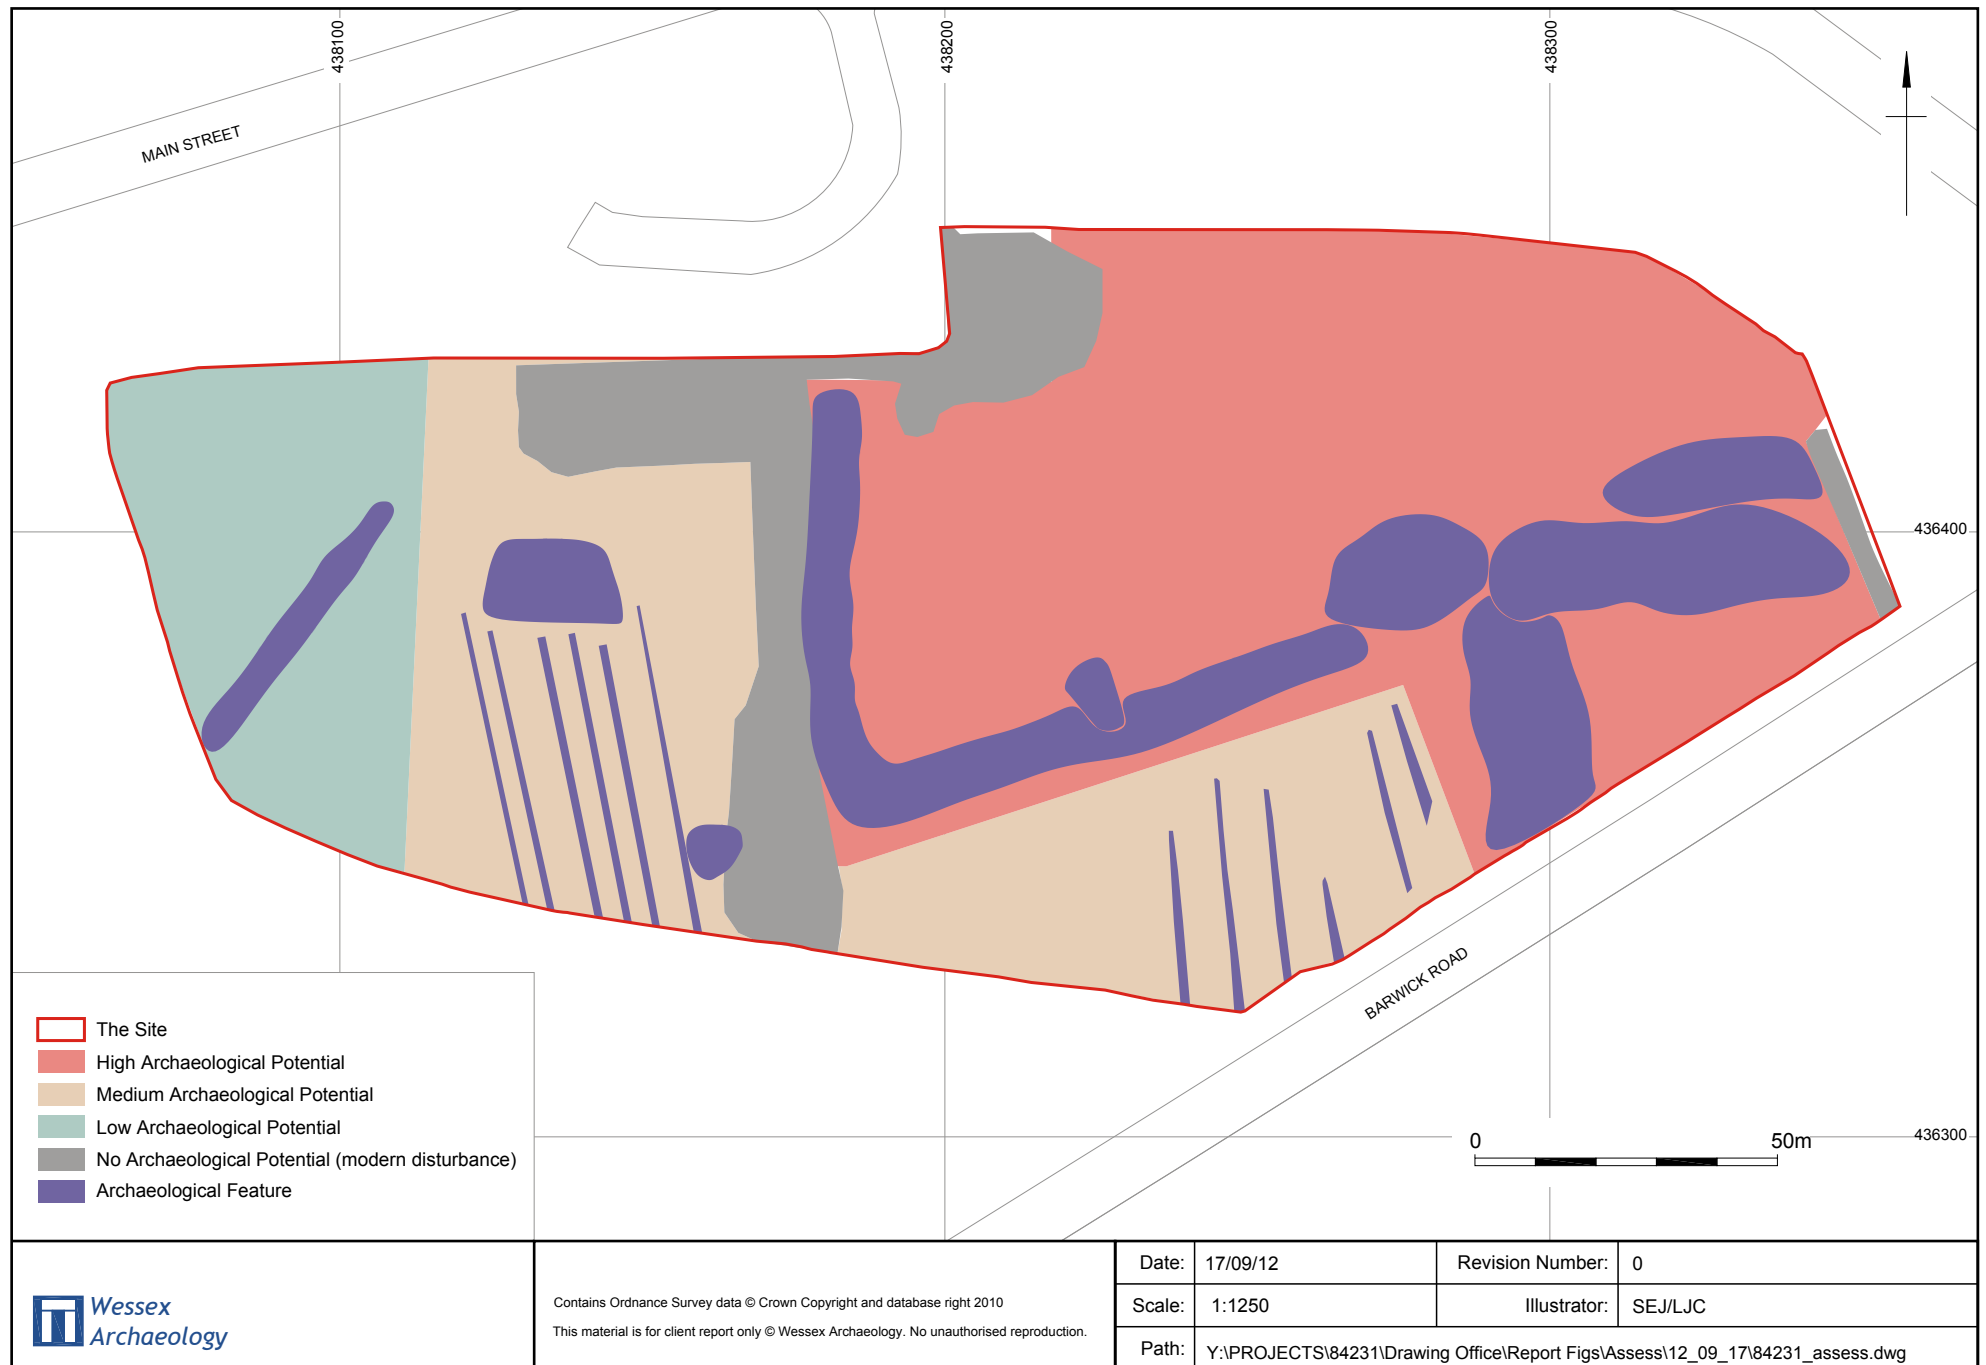
Figure 3

- 4.1.1 Based upon the above interpretation the Site can be divided into three areas of archaeological potential, defined as high, medium or low (**Figure 3**).

- 4.1.2 Medieval occupation and activity was probably focussed within the moat and annex. Beyond the moats the majority of the identified archaeological remains appear to relate to agriculture and may well post-date the manorial use of the Site. The original western extent of the manorial site is likely to be marked by the present footpath leading from Main Road through the Site. The area to the west of the footpath contains few identified or predicted archaeological features (either) and lies outside of the manorial complex; it is therefore likely to contain the lowest density of remains.

Areas of Archaeological Potential

- The pitch should be located in the area of 'low' archaeological potential (**Figure 3**), avoiding the upstanding earthwork if possible.
- Construction of a level surface should be achieved if possible using a cut and fill method to minimise the amount of excavation required. This would utilise cut material to build up the remainder of the pitch area to form a level surface.
- Due to the high potential for archaeological remains to be exposed, an archaeologist should be on site during all groundworks (an archaeological 'watching brief').

- Where possible, benches and information boards should be sited in areas of no archaeological potential (**Figure 3**).
- Due to the high potential for archaeological remains to be exposed in some areas of the Site, an archaeologist should be on site during all groundworks except in the area of 'no' archaeological potential (an archaeological 'watching brief').
